Subject: Final After-Field Summary Letter Report, Biological Surveys of the San Diego Sector (SDC) Border Wall Prototype, San Diego County, California, Task Order HSBP1017F00134, Work Order 01

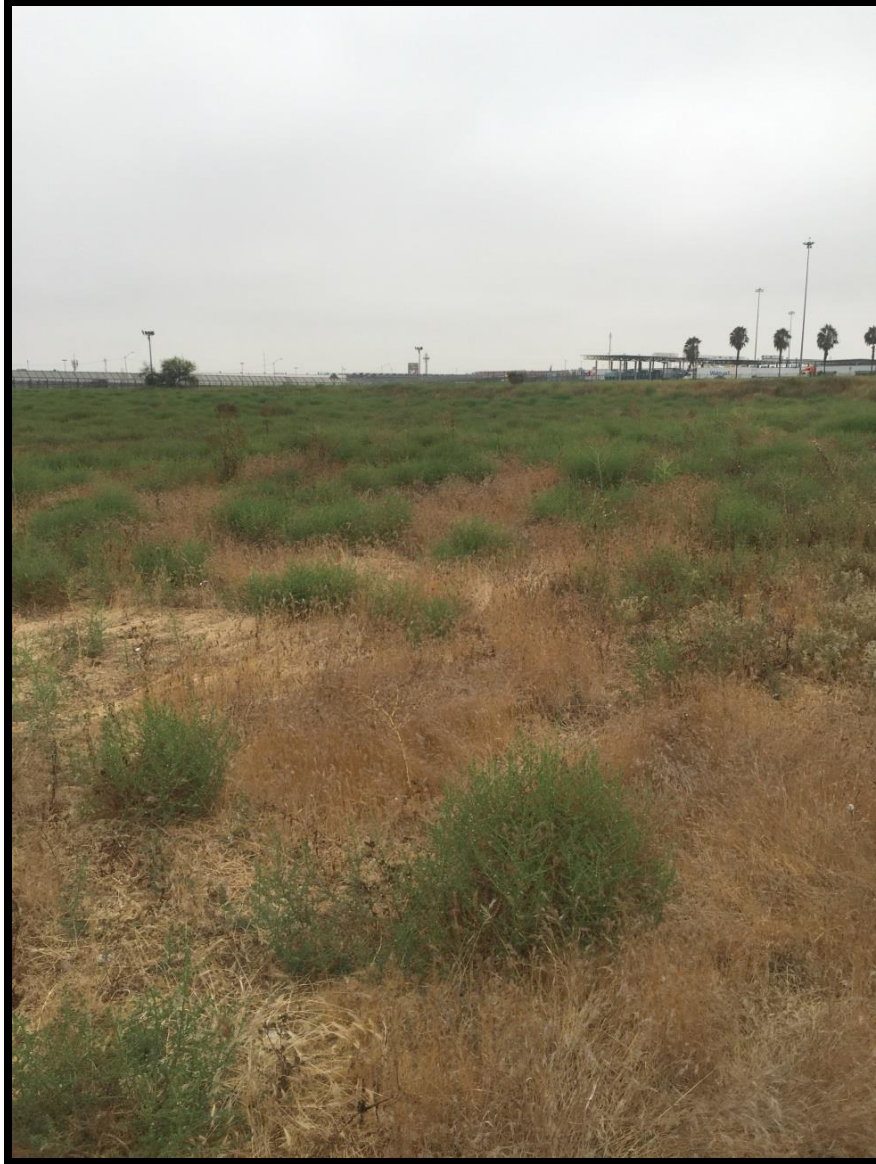
**Photograph 1. This image depicts the heavily disturbed landscape within the entry and potential staging area, dominated by non-native species; (looking southwest from northeast corner).**

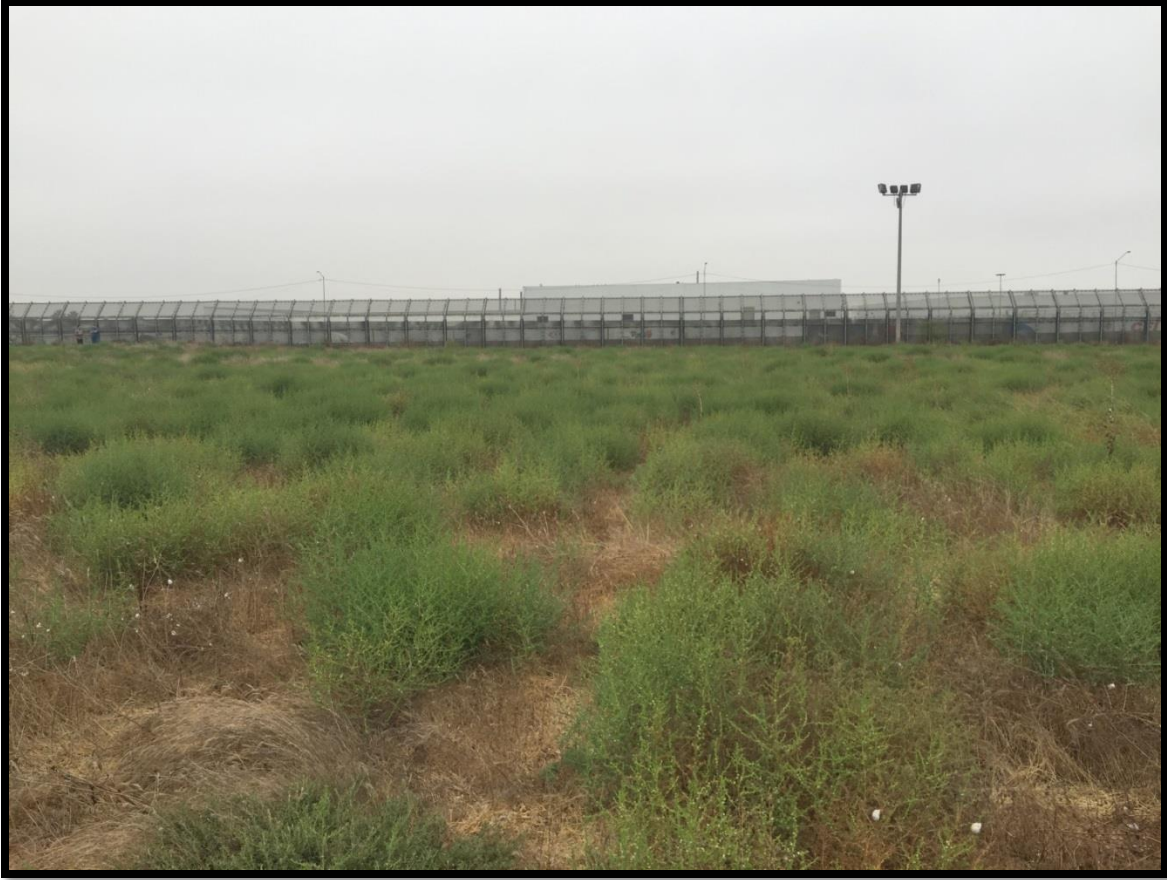
**Photograph 2. This image depicts the heavily disturbed landscape within the entry and potential staging area, dominated by non-native species (looking south from an approximate center of survey area).**

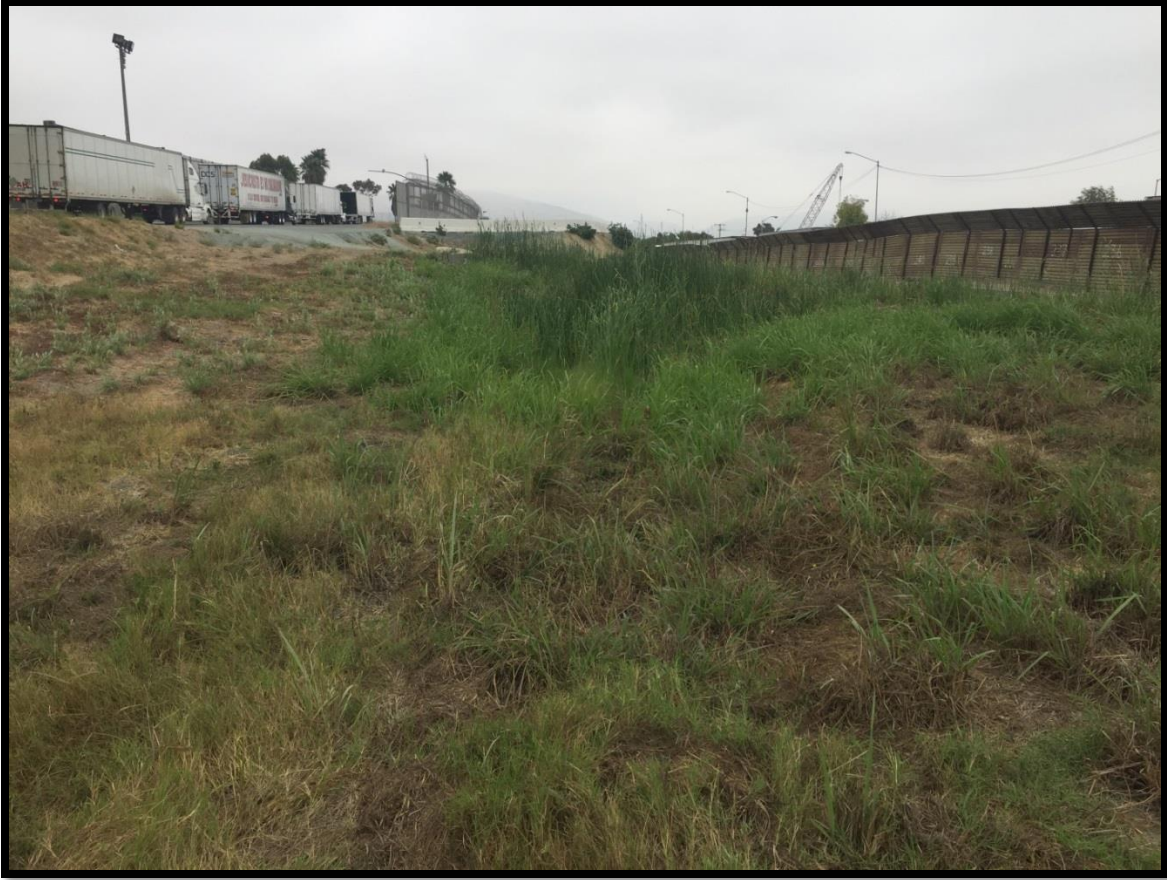
A shallow ditch within the enforcement zone to the east of the entry and potential staging area displayed vegetation and hydrology consistent with wetlands and should be considered as potential wetland habitat (Attachment B, Map 1), (Attachment C, Photographs 3 and 4).

**Photograph 3. This image depicts the potential wetland immediately south of the entry and potential staging area (looking east from eastern end of project corridor).**

The GSRC biologists identified a potential wetland area south of the entry and potential staging area within the border enforcement zone. This area should be avoided during construction activities.

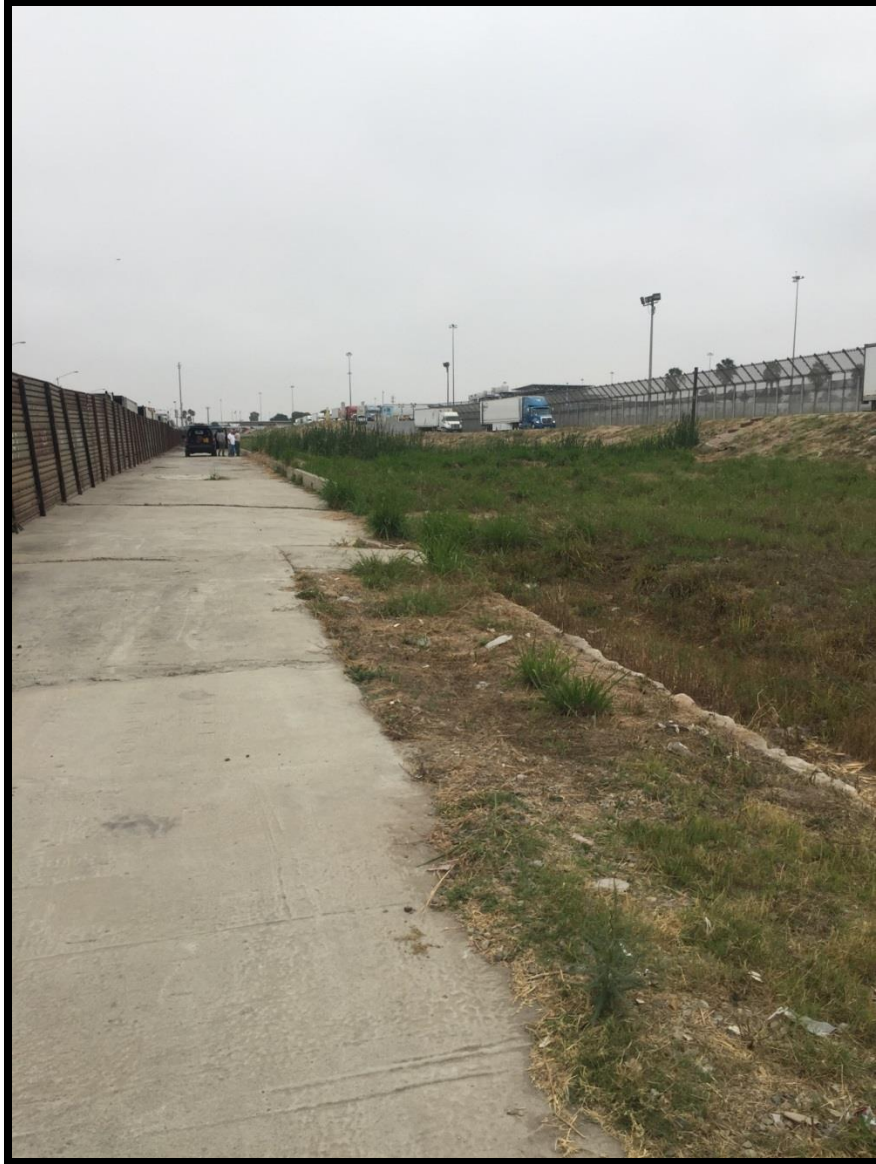
**Photograph 4. This image depicts the potential wetland immediately south of the entry and potential staging area (looking west towards the project terminus).**

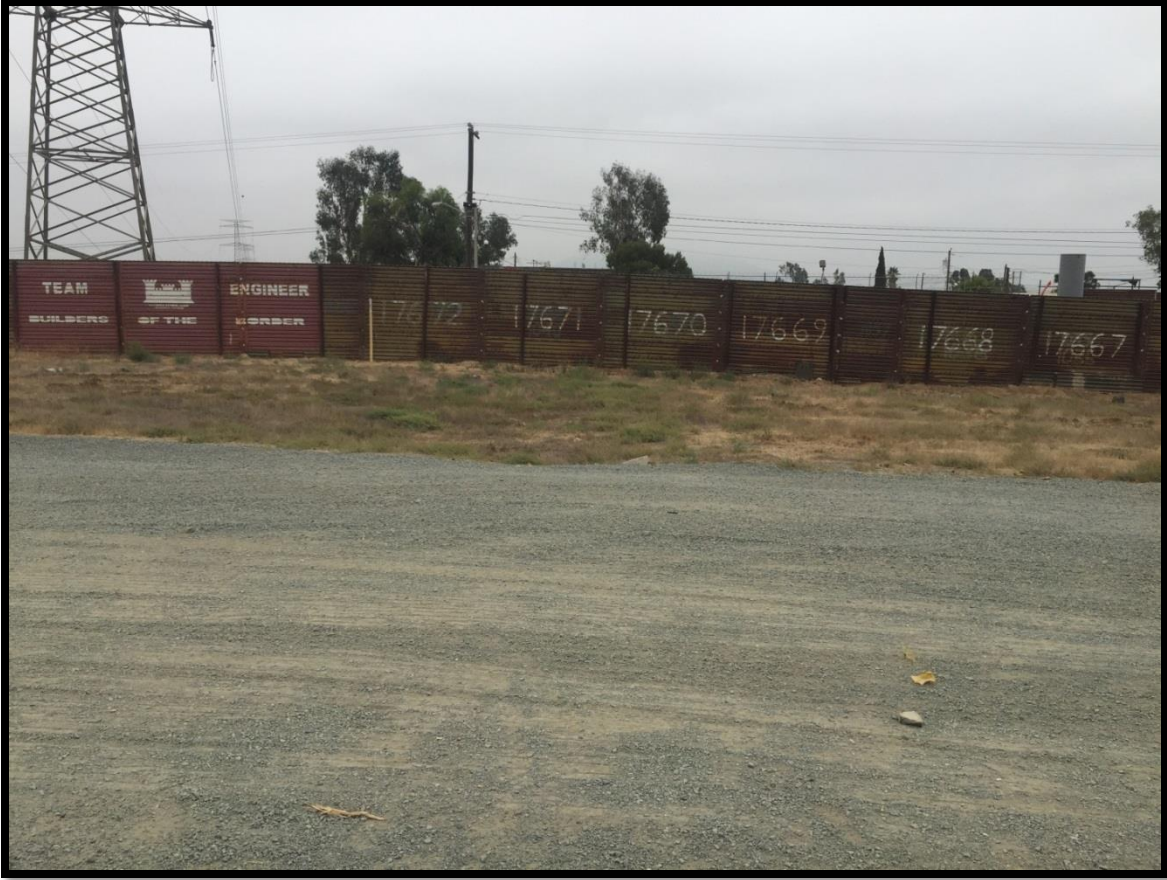
**Photograph 9. This image depicts the typical level of disturbance and conditions within the border enforcement zone survey area (looking south).**

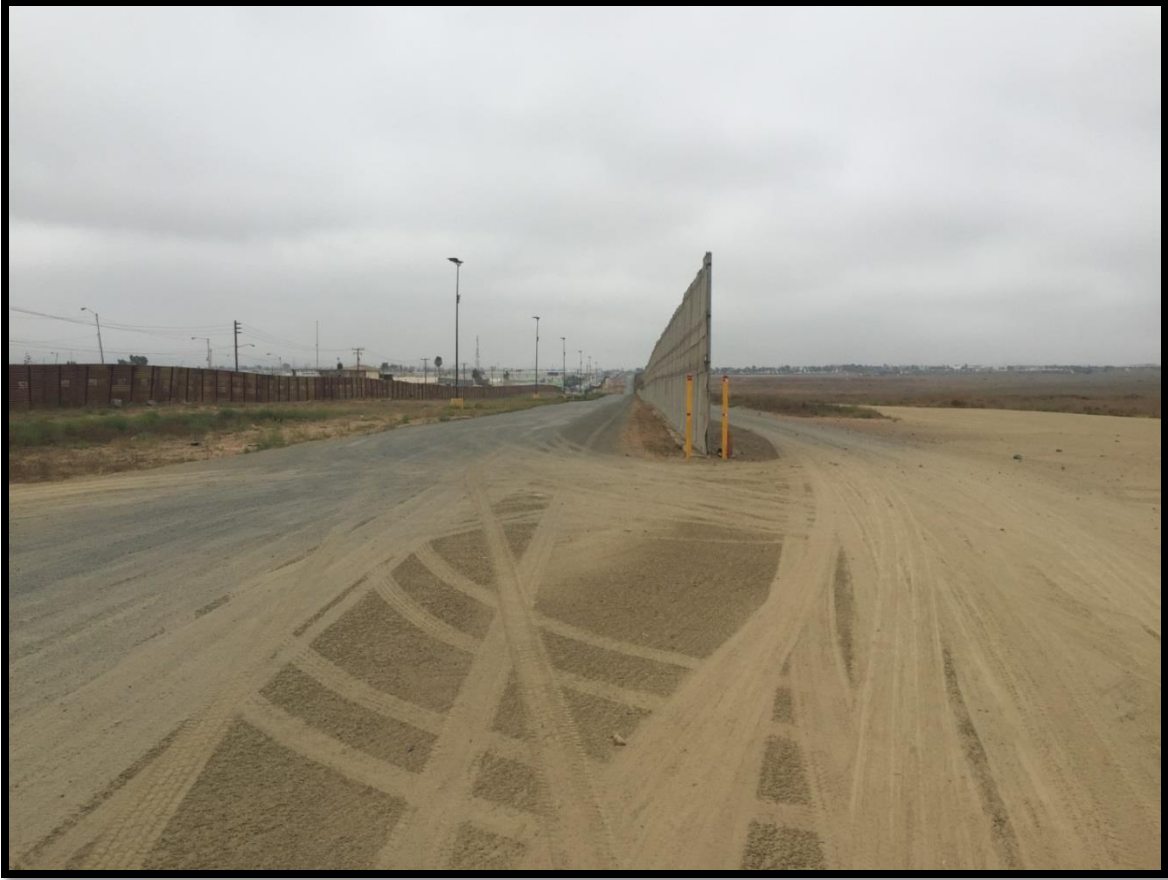
**Photograph 10. This image depicts the typical level of disturbance and conditions within the enforcement zone survey area (looking west from the eastern end of the project area).**

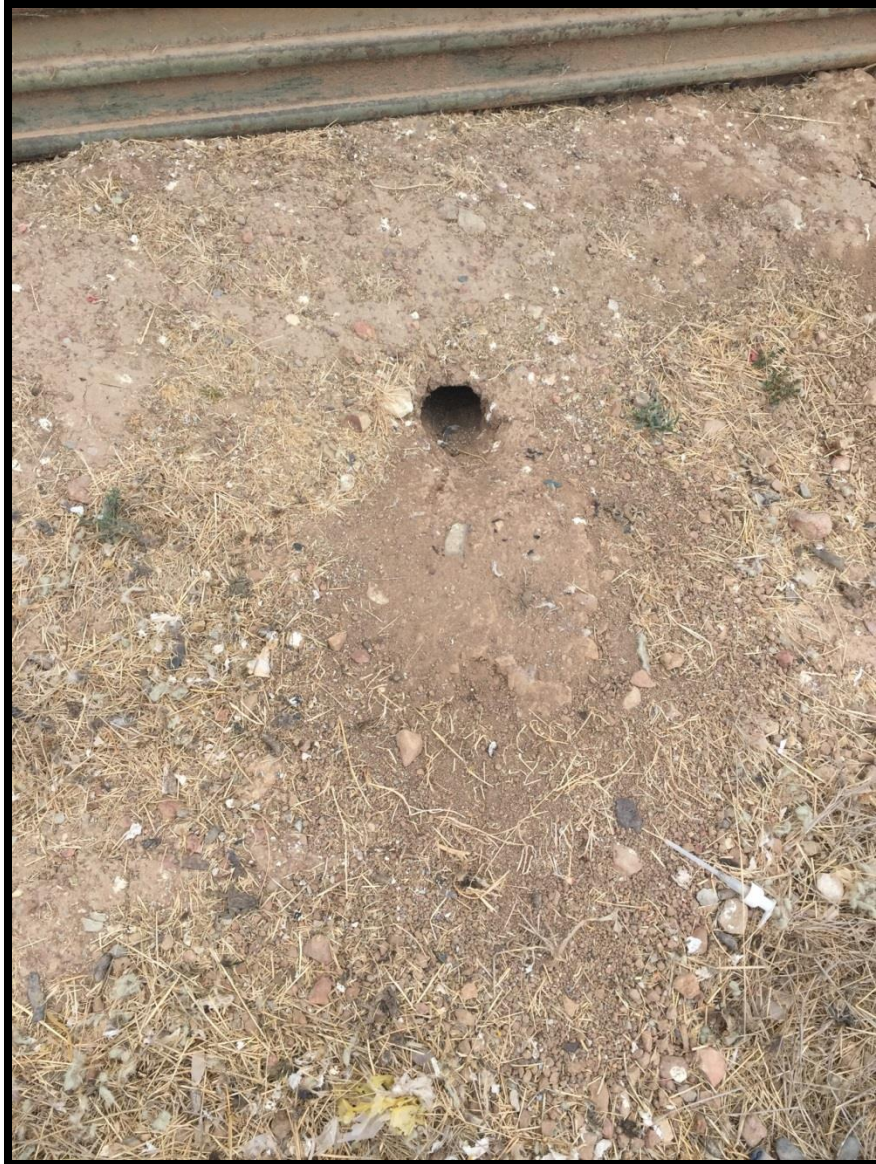
During the survey multiple BUOWs and 37 active BUOW burrows were observed in this area. GSRC biologists reported 19 BUOWs, 12 of which were observed at burrow sites (Attachment C, Photograph 11). An absolute count of BUOWs was difficult to make as a result of multiple owls flying up and down the survey corridor. The position of all active burrows and burrows with owls observed was taken using a handheld Trimble™ global positioning system (GPS) unit capable of sub meter accuracy. These burrow locations are depicted on Maps 1, 2, and 3 in Appendix B. California Department of Fish and Wildlife (CDFW) recommends a 50-meter buffer around active BUOW burrows during the non-breeding season (September 1 through January 31) (CDFW 1995, California Burrowing Owl Consortium [CBOC] 1993).

**Photograph 11. This image depicts an active burrowing owl burrow with invertebrate prey remains, whitewash, and decoration display.**

The GSRC biologists identified multiple active BUOW burrows and BUOWs within the border enforcement zone. These areas were mapped and given a 50-meter buffer zone. To avoid disturbance of the BUOWs and BUOW burrows, care should be taken to keep all construction activity and equipment staging outside of these 50-meter buffer zones. Construction traffic through this area should be limited to the all-weather road and traffic should be restricted to 25 miles per hour. All construction personnel should be made aware of the protected status of BUOWs and general knowledge of this species identification and biology prior to admittance to the site.

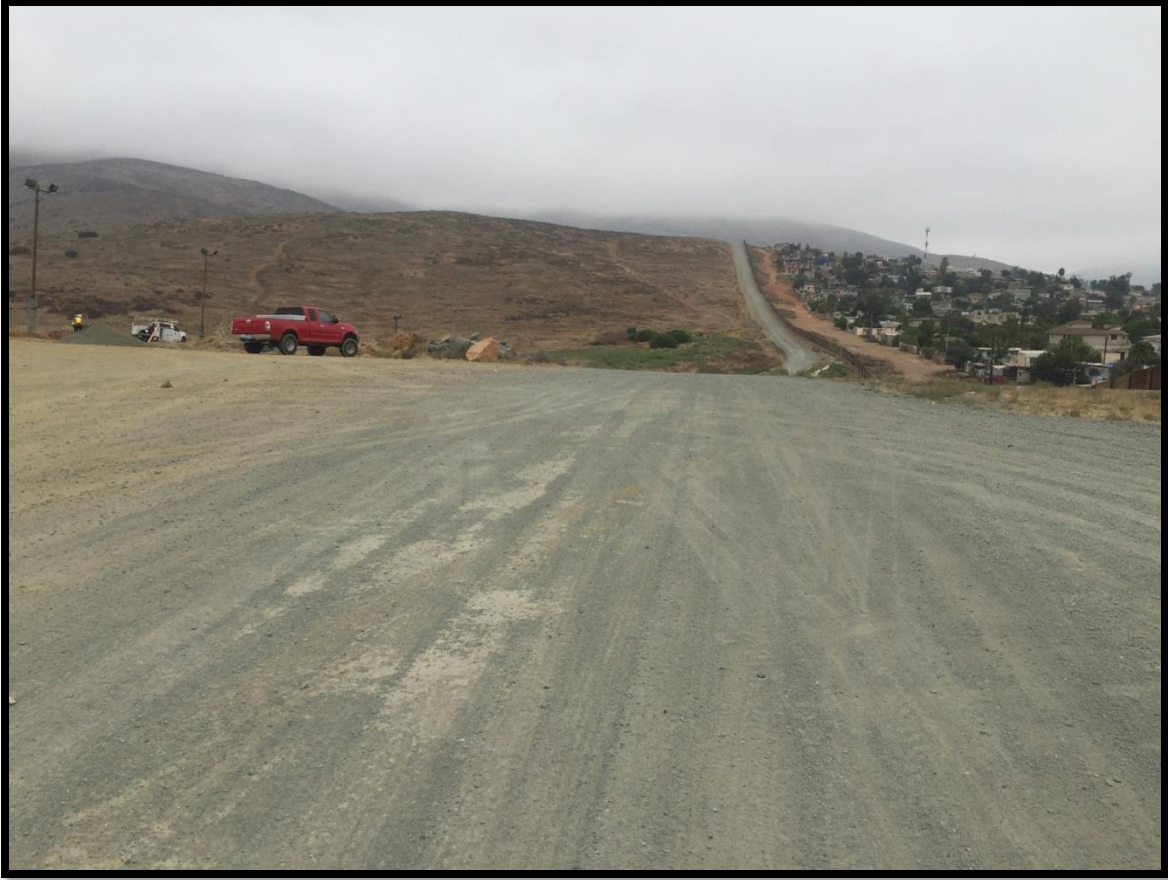
**Photograph 12. This image depicts the typical level of disturbance and conditions within the prototype construction survey area (looking east from the eastern end of the secondary fence).**

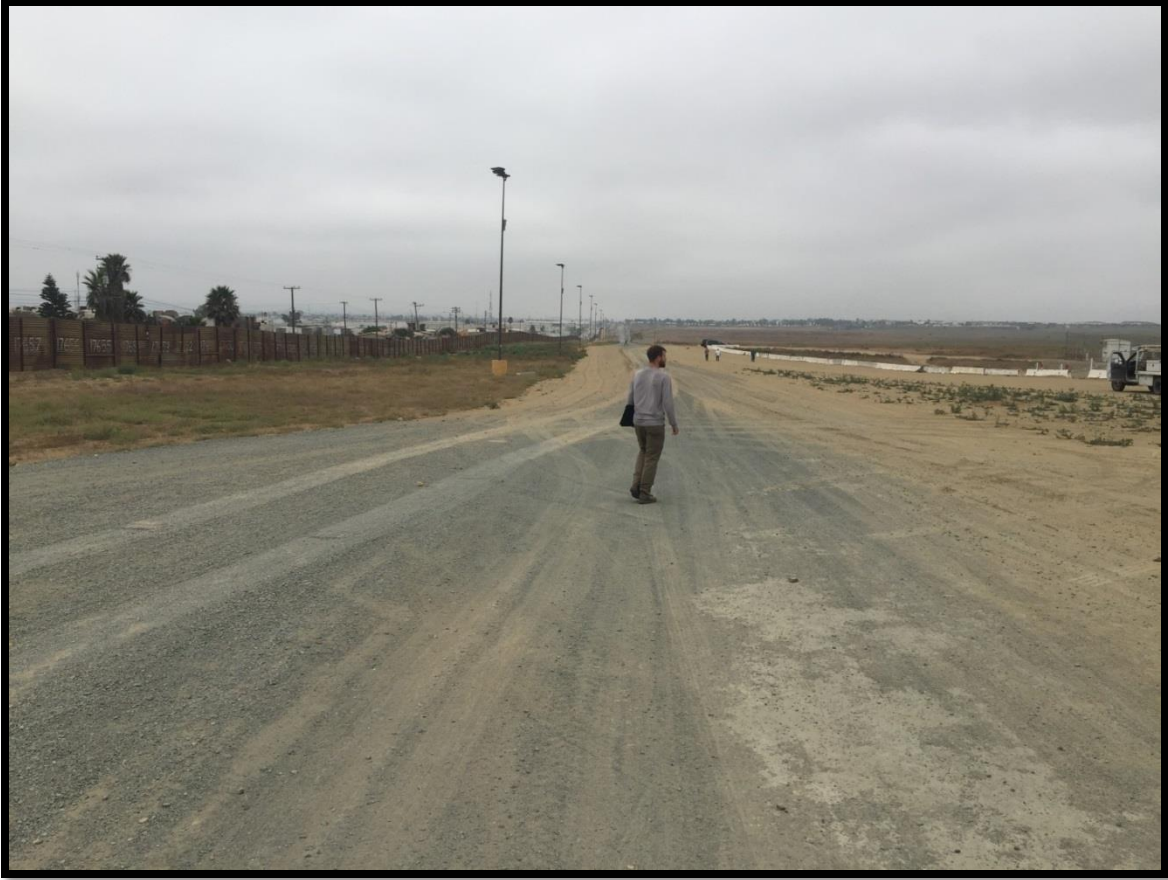
**Photograph 13. This image depicts the typical level of disturbance and conditions within the prototype construction survey area (looking west from the eastern end of project area).**
