PSITEC.DHS2011.0189 **January 26, 2009**

Operational Test and Evaluation Performance Report:

Halcyon FireGround Compass®, Version 1.1

TechSolutions Program
Department of Homeland Security, Science and Technology Directorate
Washington, DC

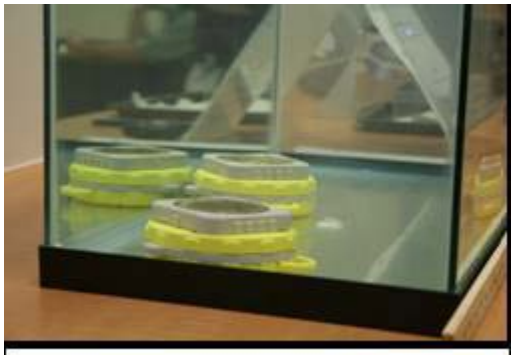
Figure 5-1: Submersion of UUTs

EKU001	EKU002
Exterior Casing	No damage or deformation	No damage or deformation
Building Bezel	Operational	Operational
Command Bezel	Operational	Operational
Light	Operational	Operational
Battery Compartment	Moisture observed	Moisture observed
Circuit Board	Moisture observed, no corrosion, no discoloration	Moisture observed, no corrosion, no discoloration
Batteries	Moisture observed, no corrosion, no discoloration	Moisture observed, no corrosion, no discoloration
Water Intrusion	Moisture under the cover plate	Standing water under the cover plate

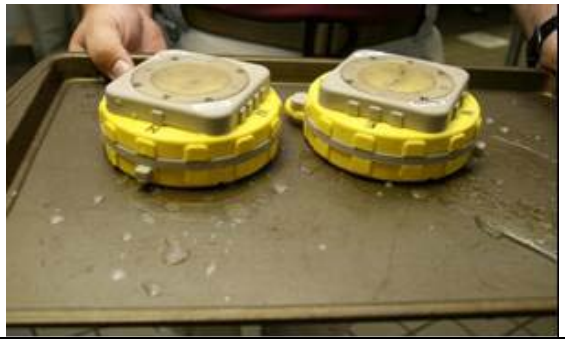
Figure 5-2: Ice Formation on UUTs

EKU007	EKU 008
Exterior Casing	No damage or deformation	No damage or deformation
Building Bezel	Operational	Operational but felt stiff
Command Bezel	After 360° rotation to clear ice, bezel was operational	After 360° rotation to clear ice, bezel was operational
Compass	Operational	Operational
Light	Operational	Operational
Pre-Test UUT Skin Temperature	68.5° F (20.3° C)	71.0° F (21.7° C)
Post-Test UUT Skin Temperature	-4.0° F (-20° C)	-8.0° F (-22.2° C)

The findings from the Icing Conditions test indicate that both units continued to be functional when exposed to freezing temperatures.
